KENWOOD ROAD ACCESS MANAGEMENT STUDY  
Sycamore Township, Ohio

TEC PN – 11102-001  
August 2011

## **CORRIDOR STUDY**

### **Kenwood Road Montgomery Road to Euclid Avenue Hamilton County, Ohio**

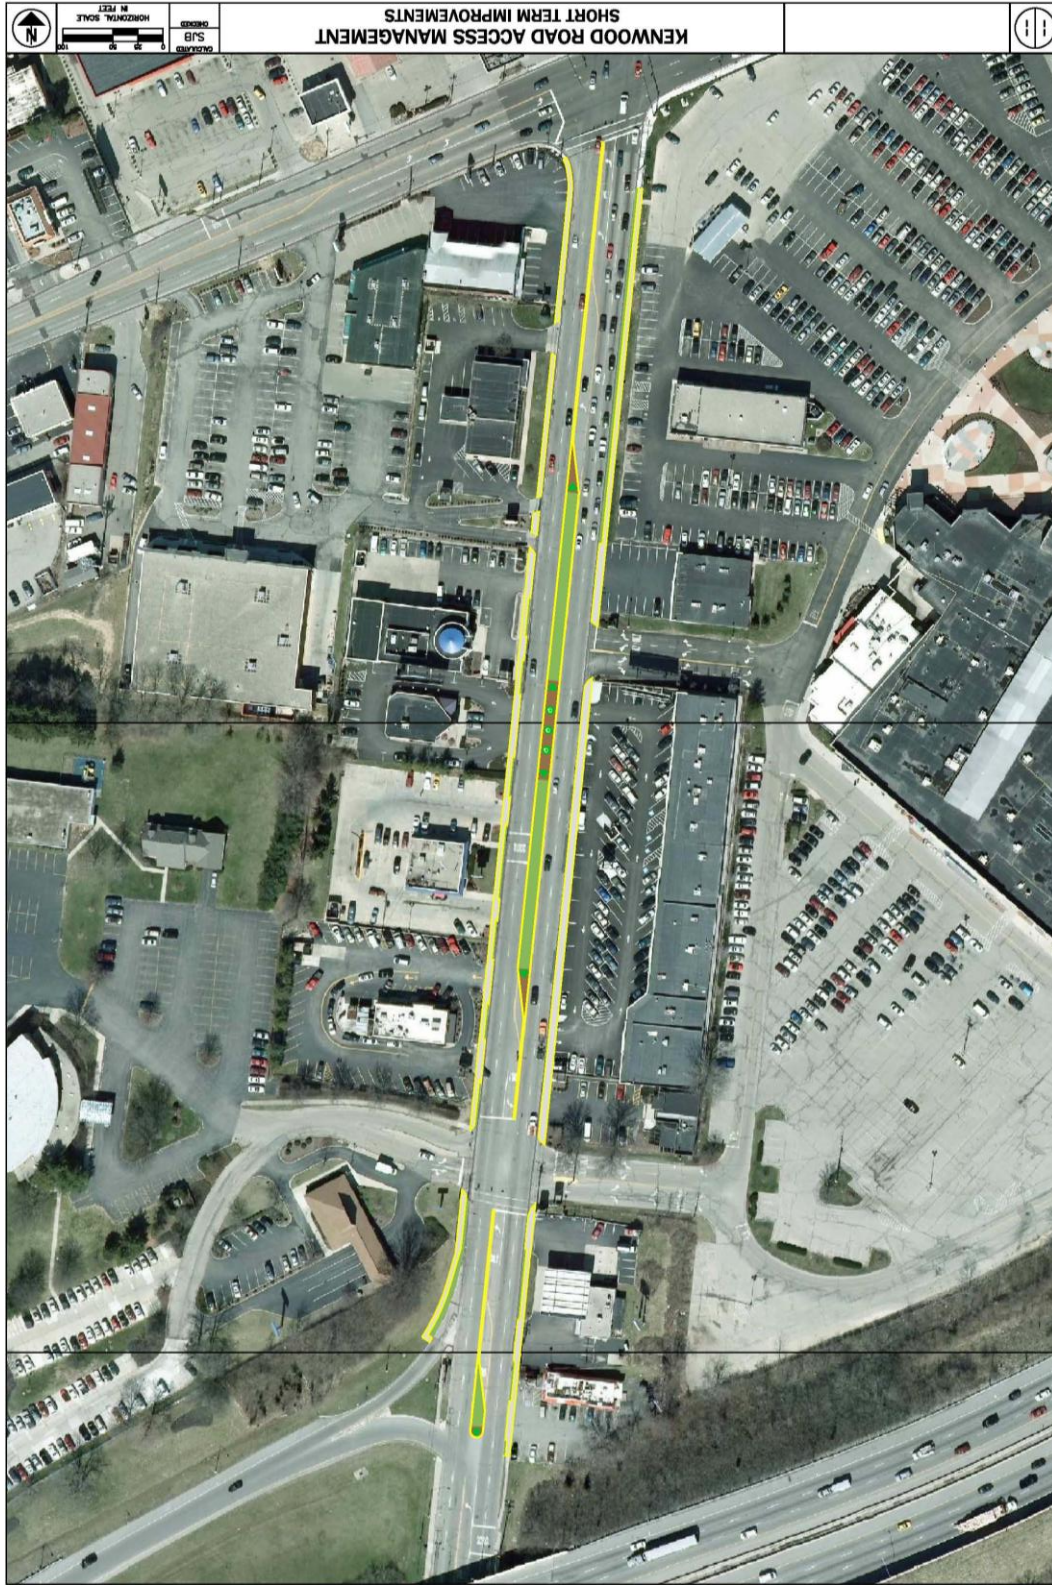
*Figure 6: Short Term Recommendation*

In the short term, it is recommended that a median is constructed through the corridor. This median would prevent left turns at all unsignalized accesses. Left turn lanes are necessary at the intersection of Sycamore Plaza/St. Vincent Ferrer and Kenwood. In order to accommodate future traffic, the northbound left turn lane should be 150' and the south bound left turn lane should be 200'. The storage length includes a 50' taper. The existing left turn lane at Kenwood and Montgomery was also reviewed for length. This turn lane should be 425'. A small median should be built along the turn lane to prevent crossing traffic. This concept is shown in *Figure 6*.

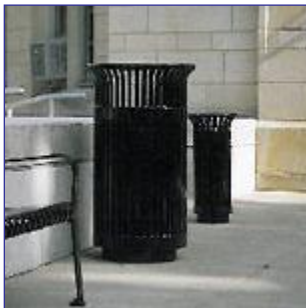
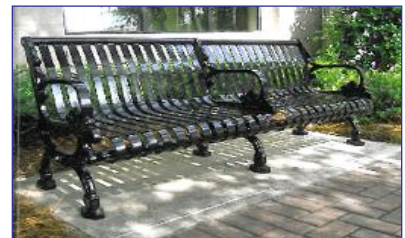
The Kenwood Road corridor is a very urbanized corridor with little streetscaping or hardscaping. It is recommended that the Township implement a streetscaping plan along the corridor to beautify the street and make it more attractive to visitors and residents. TEC has included some designated areas for plantings, including some in front of businesses, as well as locations within the right-of-way. Street furniture could be added along the project corridor to improve the functionality of the corridor. This could include garbage cans, benches, etc. These could be especially useful near the bus stops along the corridor.
